WASEL RESERVOIR DAM

CT. 00260

PHASE I INSPECTION REPORT
NATIONAL DAM INSPECTION PROGRAM

DECEMBER 1978

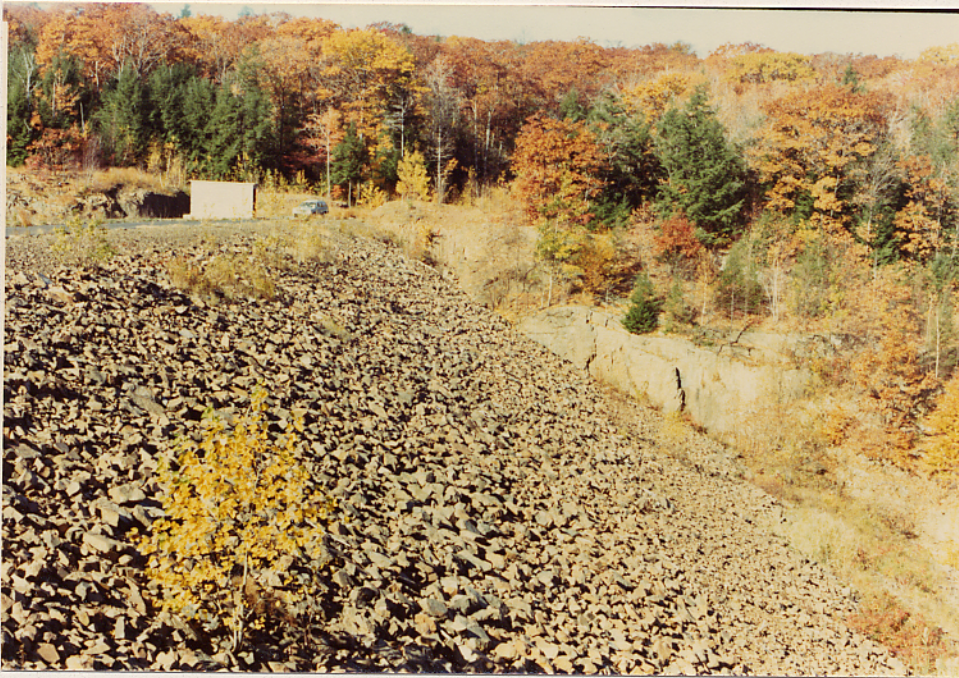
The horizontal and vertical alignment and the condition of the crest of the dam are good. There is a paved road at the top of the dam about 10 ft. wide which shows some signs of minor deterioration. Appendix C, Photo No. 1, is a general view of the downstream slope of the dam. Note the generally good condition of the dumped rock face of the dam. There is some minor brush growth, generally not exceeding about 8 ft. high, on the downstream slope from the toe up to about the 1/3 point.

1. Downstream slope of main dam from right abutment

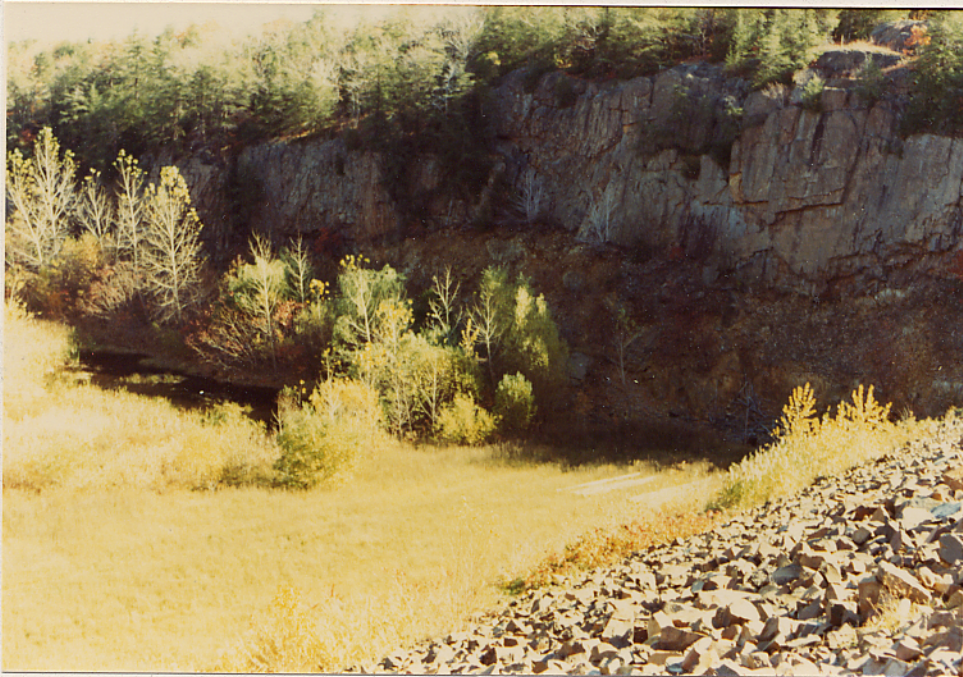
2. Pool of water below downstream toe of main dam

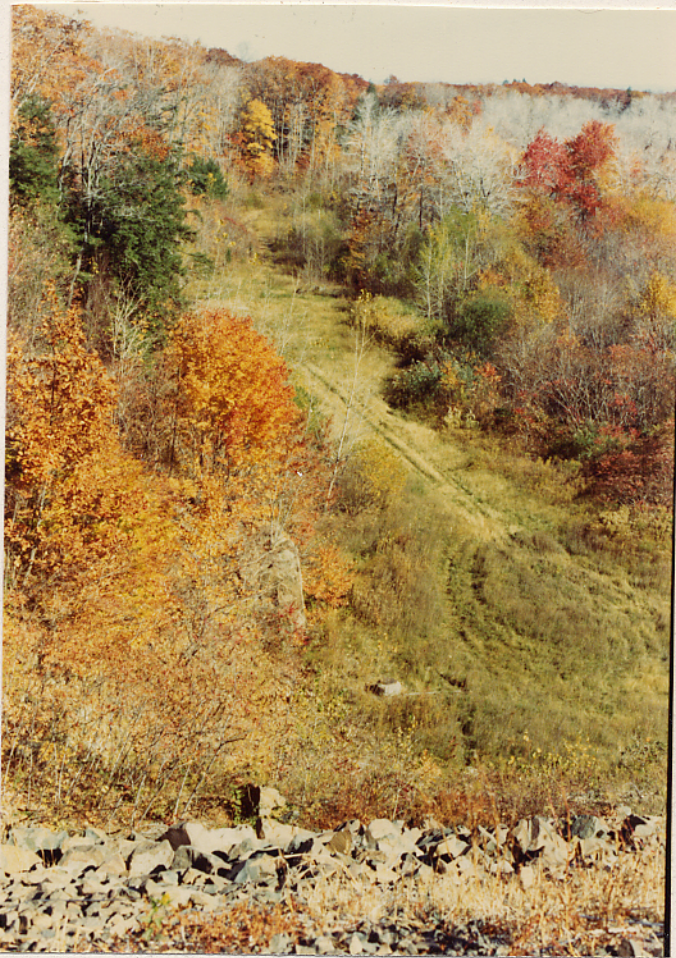
3. Downstream valley from main dam, showing manhole

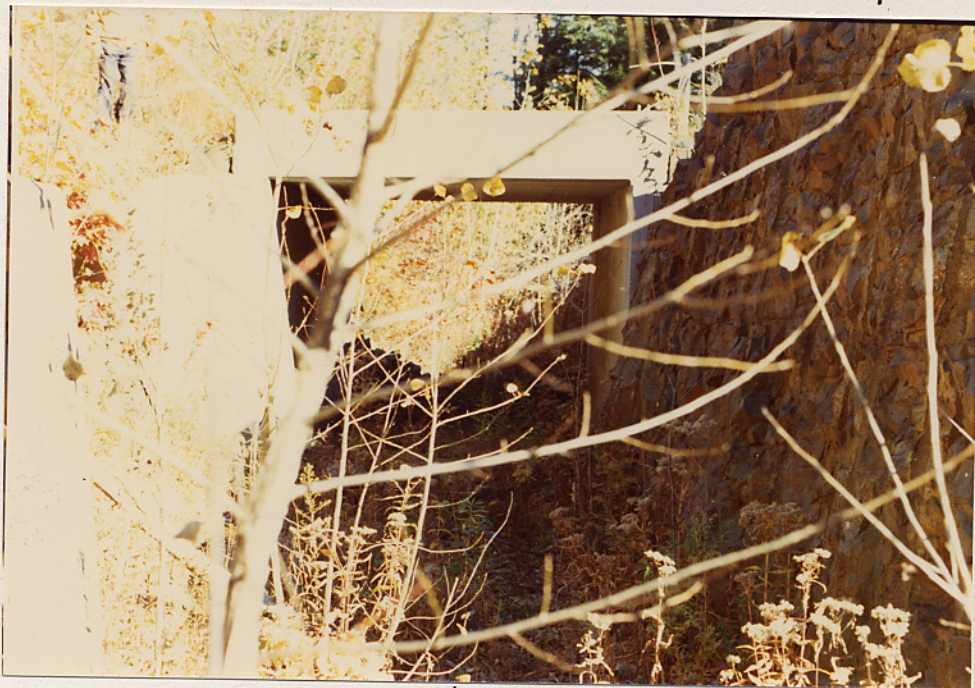
4. Access road bridge across spillway outlet channel

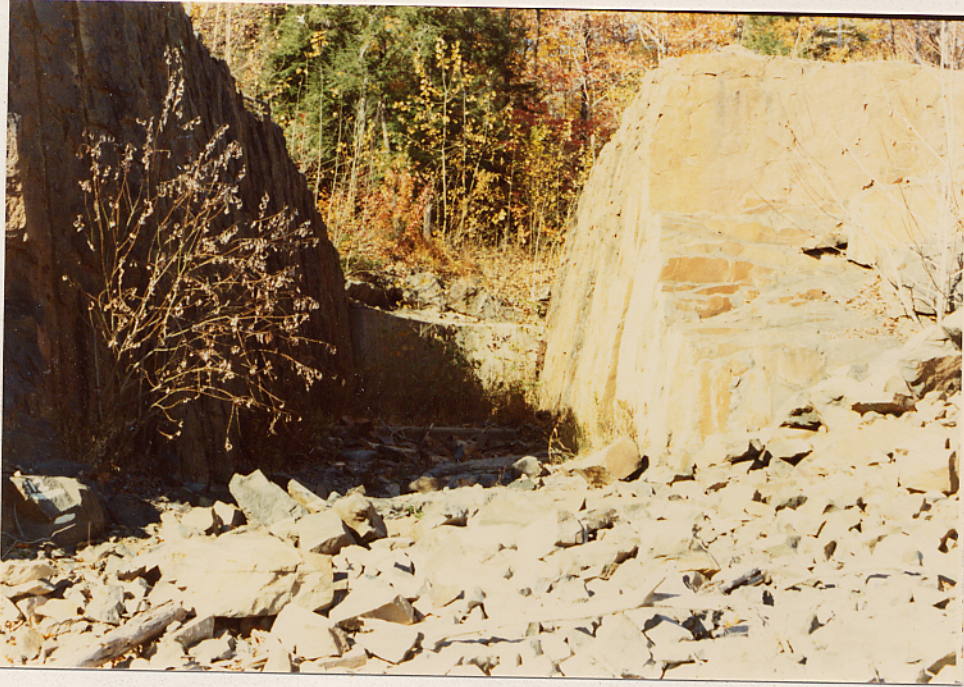
5. Spillway approach channel & concrete sill

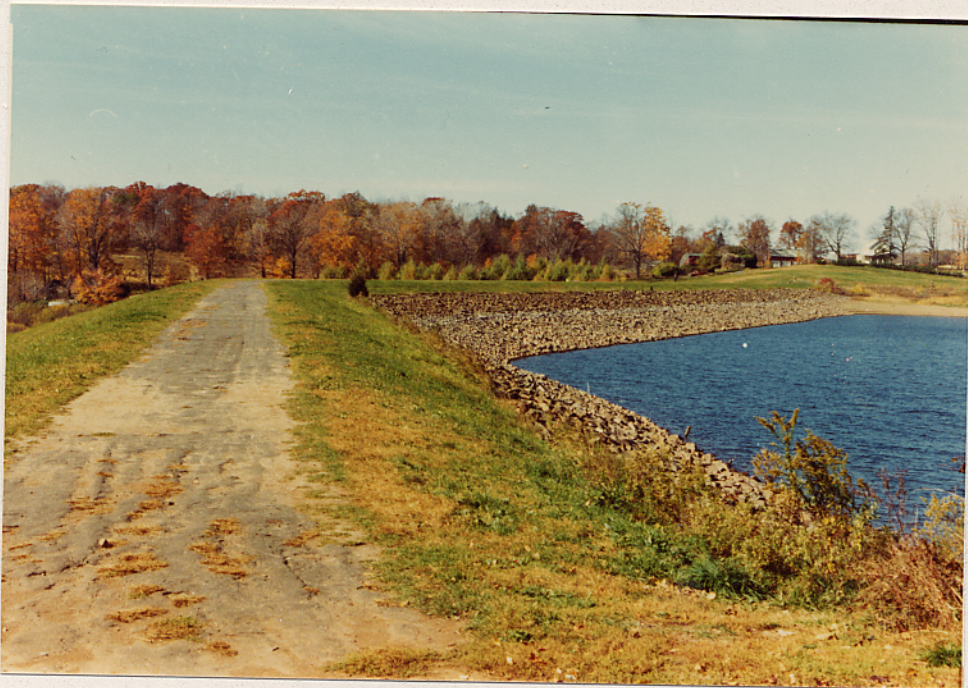
The south dike of Wasel Reservoir was also viewed (Appendix C, Photo No. 6). The alignment, both horizontal and vertical, is good and the crest of the dike is in good condition. The bituminous pavement of the crest is in fair to poor condition. The riprap on the upstream slope of the dike is in excellent condition. The downstream slope is also in excellent condition. It is a grass slope with a berm about two-thirds of the way down, with no evidence of any bulges or movement of the slope. The lower portion of the downstream slope below the berm is covered with light brush growth. As one proceeds from the right abutment towards the left abutment, the dike takes a bend in the upstream direction about two-thirds of the way across the length of the dike. Just to the left of where this bend occurs, there is an outlet for a toe drain and a concrete manhole measuring about 6 ft. wide and 4 ft. deep. The outlet pipe from this manhole is a cast iron pipe and some minor seepage of approximately 1 or 2 gallons a minute was observed. The water was clean and clear.

There are some catch basins located at the berm level on the downstream slope which were noted to be dry at the time of the inspection. A second toe drain discharge located closer to the right abutment was also inspected. This is a reinforced concrete square manhole with a rim on it and the water just at the toe of this was observed to be clear. No evidence of springs or major seepage was noted along the downstream slope. There is a wet area right at the toe of embankment near the manhole which is about 6 ft. wide and perhaps 20 ft. long. The total visible seepage emanating from this point is probably of the order of 10 gallons a minute and the seepage is clear, clean water.

With the exception of the two seepage points previously noted, there is no evidence of seepage along the downstream toe below the berm level for most of the length of the dike. However, there is a marshy area at the downstream toe of the berm on the downstream slope, from a point about 300 ft. from the right abutment and covering an area approximately 300 ft. long and 100 ft. wide. The toe of the downstream slope below the berm is wet through this whole area, but the water source which maintains this wet area was not evident. The reservoir level was down about 11 ft. below normal, such that foundation seepage would be reduced, if that is the cause of the high water table. Another possible source which may maintain the wet area is leakage either from the 6 in. dia. outlet or from the 16-in. dia. pump line stub leading from the outlet tower. It was not possible during the inspection to investigate this latter premise.

6. Overview of south dike from left abutment

3. The seepage at the downstream toe of the south dike should continue to be monitored for quantity and clarity on a yearly basis.
4. The wet area downstream of the toe of slope at the right abutment of the dike should be studied to determine the cause and whether the use of drainage ditches and/or trenches is feasible. Test borings and groundwater monitoring might be required for such a study. However, a definitive recommendation is beyond the scope of this report.

It is recommended that the owner should retain the services of a competent registered professional engineer to make investigations, studies, and, if proved necessary, design remedial works to rectify the seepage and wet area downstream of the toe of the south dike.

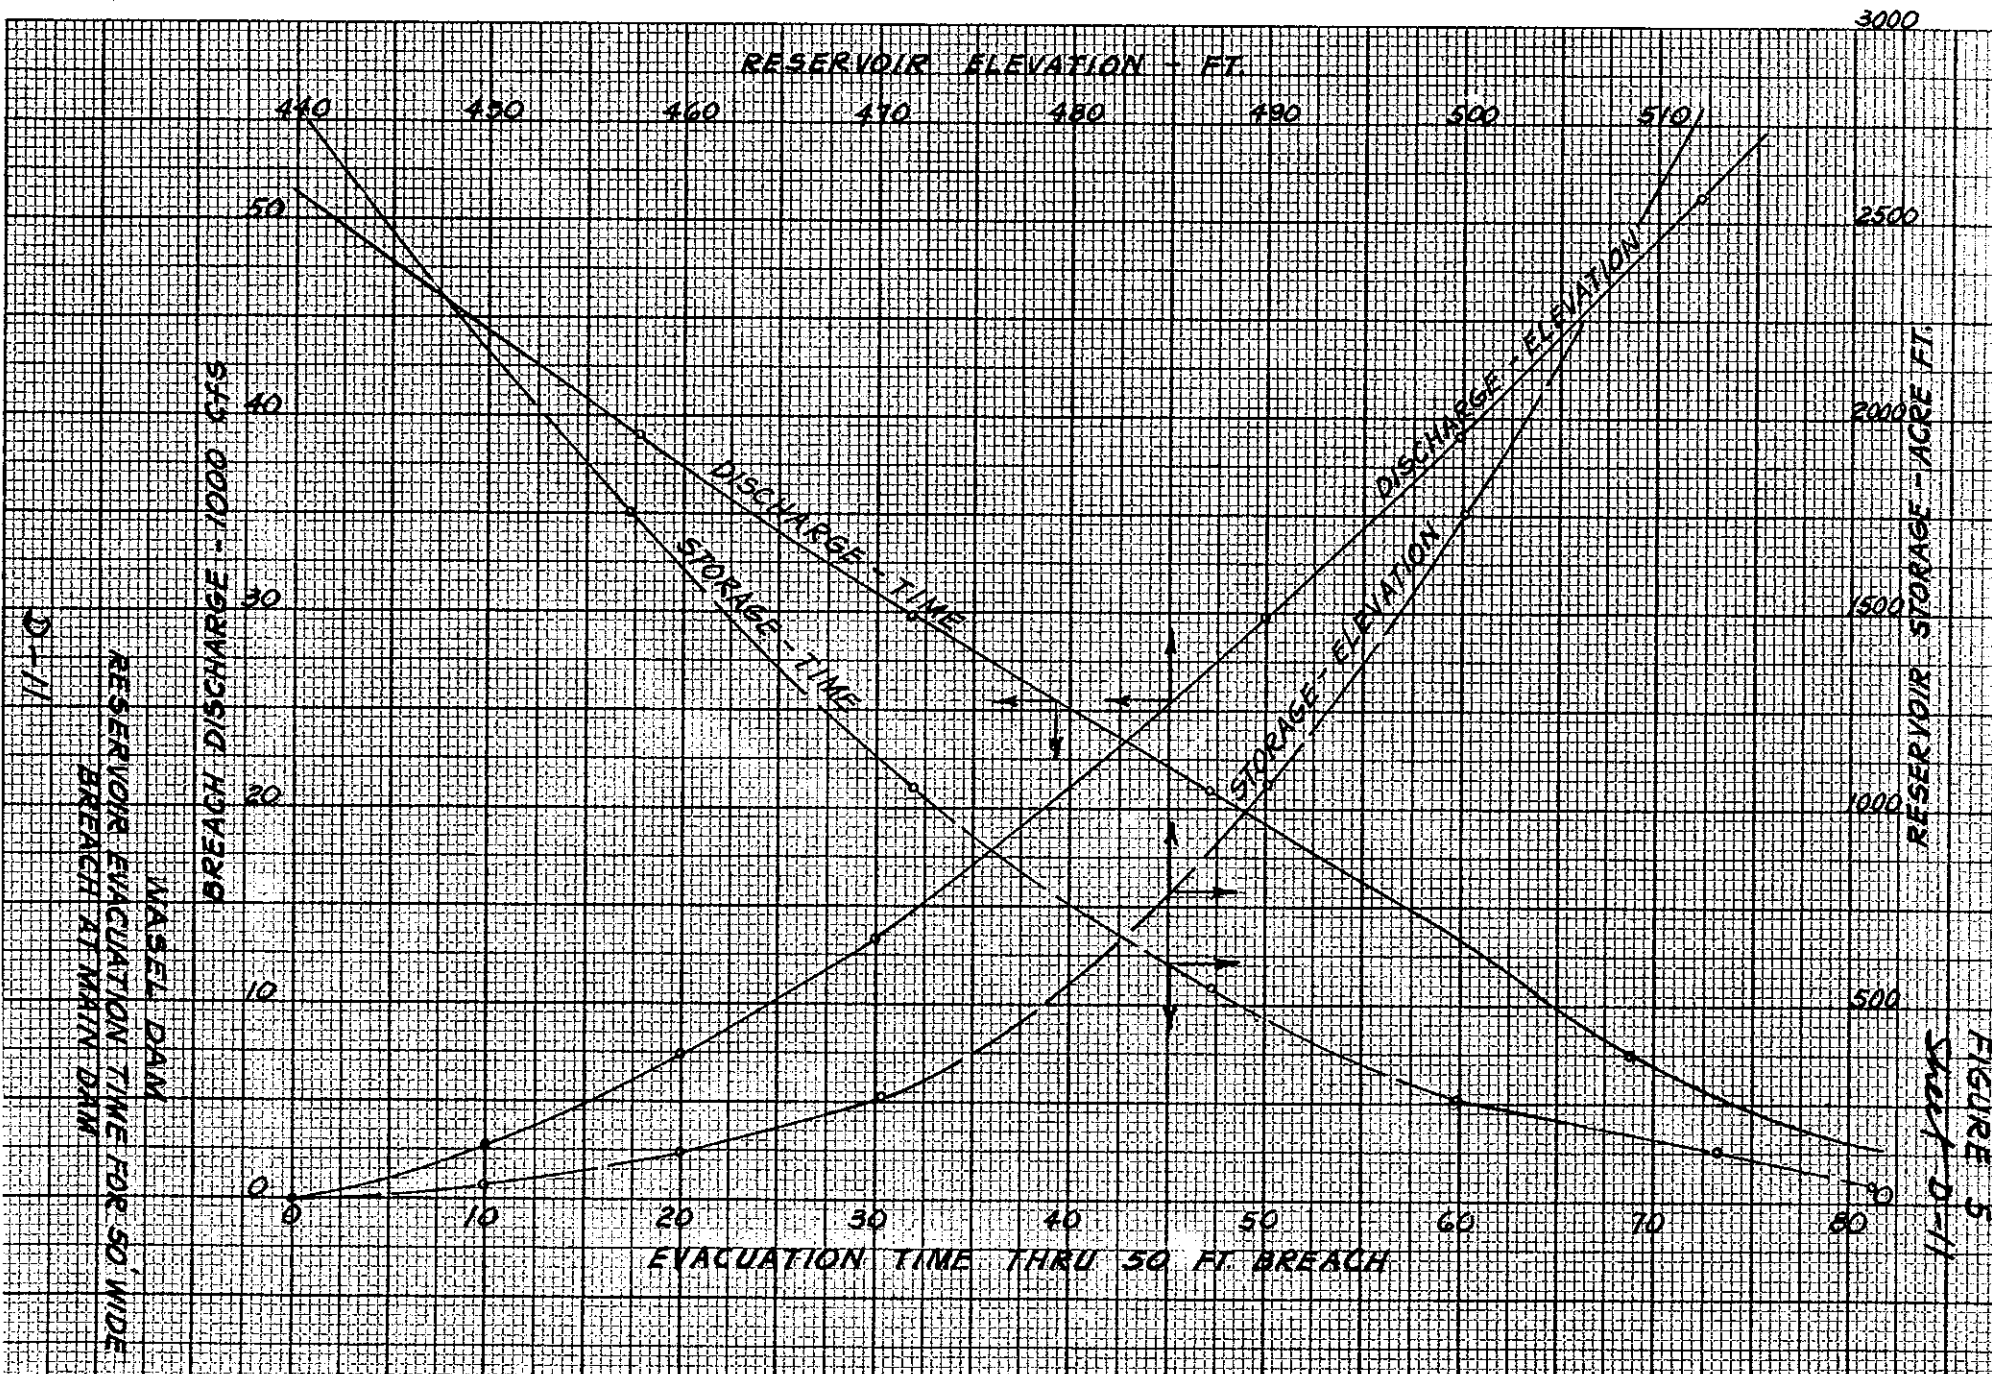
FIGURE 5
Sheet D-11

Breaching of the main dam or south dike by overtopping is most unlikely, as noted in Section 5.1d, but a breach because of structural failure of the dam or dike by piping or sloughing could occur. A breach from that cause would be similar to that from an overtopping and the "rule of thumb" criteria suggested in the NED March 1978 Guidance Report would be applicable. For a 100 ft. wide sudden breach failure washing out to the base of the main dam, a release up to 100,000 cfs. could empty into the downstream valley; a 50 ft. breach failure would release up to 50,000 cfs. On the basis of a 50 ft. breach, plotted on Figure 5, Sheet D-11, are curves showing discharge and reservoir elevation versus emptying time.

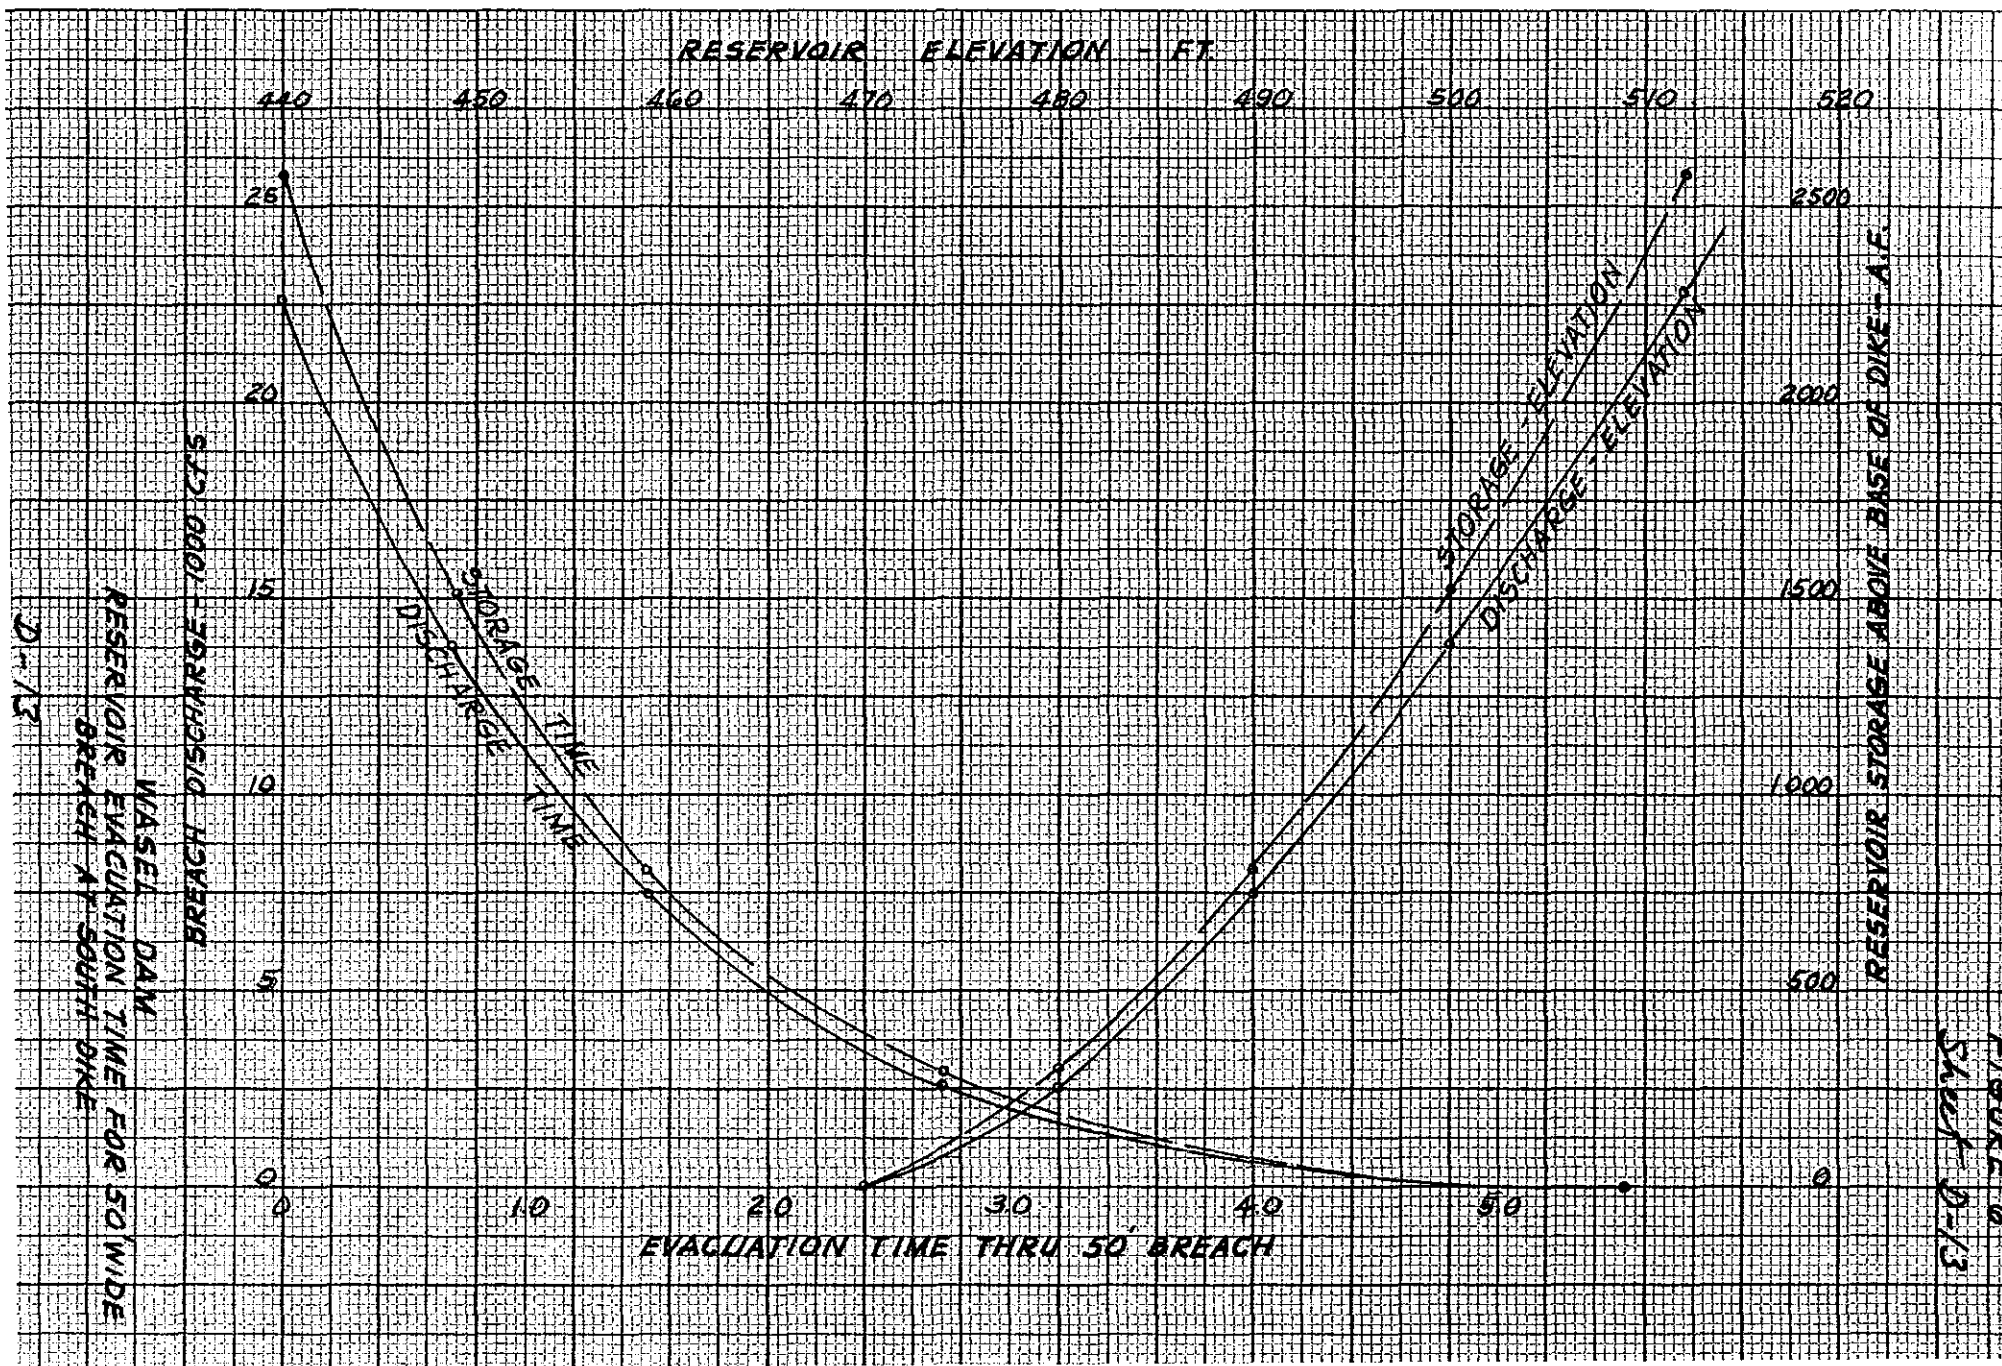
FIGURE 6
Sheet D-13

At the dike a 50 ft. breach failure would release up to 23,000 cfs. Plotted on Figure 6, Sheet D-13, are curves showing discharge and reservoir elevation versus emptying time for a 50 ft. breach at the dike.
